Vehicle: All Technical Service Bulletins

Technical Service Bulletin # 06-00-89-054

Subject:
Warranty Claims Submission - Importance of GM Part Numbers and Date Coded Parts

Models:
2007 and Prior GM Passenger Cars and Light Duty Trucks
2003-2007 HUMMER H2, H3
2005-2007 Saab 9-7X

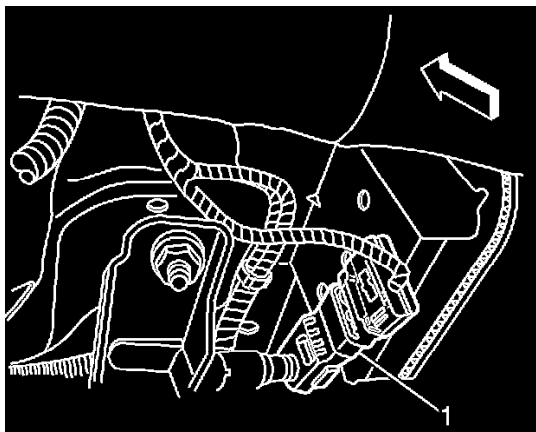
Locate the PPS sensor (1) and inspect the harness for proper routing. If the harness is pinched between the seat frame and the track/riser, use the procedure listed below to repair wire(s).

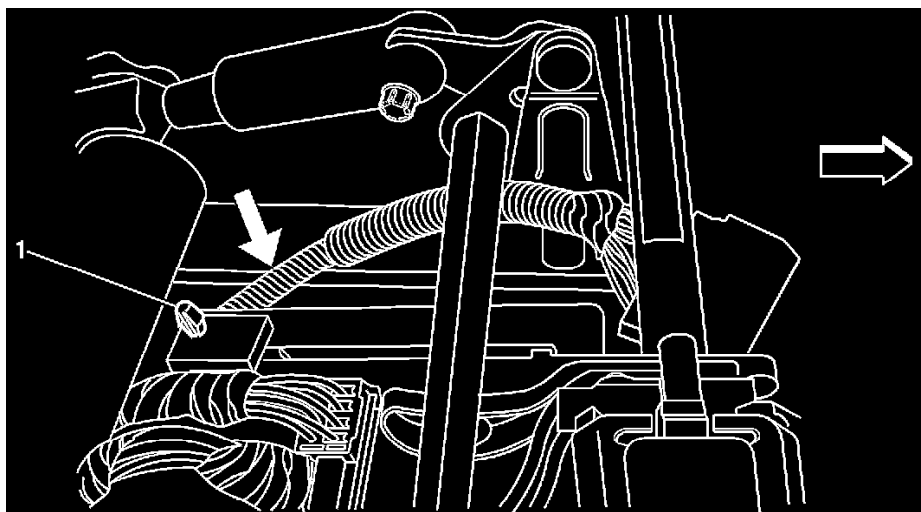
On RPO AN3 equipped vehicles, a chafed or pinched seat wiring harness under the driver seat may be a cause of this condition. Because of the routing, a portion of the seat wiring harness may rest on the inboard edge of the seat track or frame. Over time, the harness may be pinched or chafed because of the seat movement. Refer to the above illustration. The illustration shows the inverted position of the seat bottom. The arrow shows the primary location of the possible harness chafing/pinching.

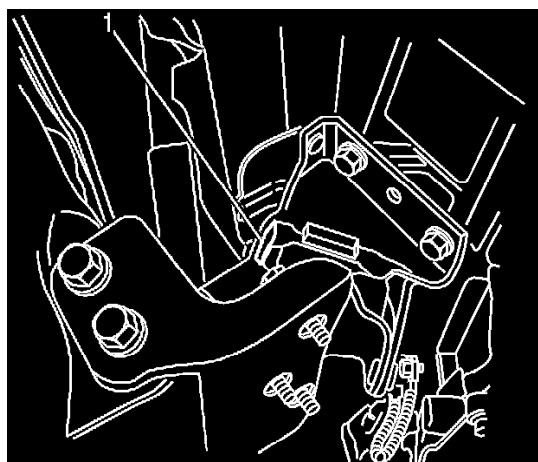
2. Inspect the engine mount(s) for close (1.5 mm (0.059 in) or less) or contact condition at outboard gap (1).

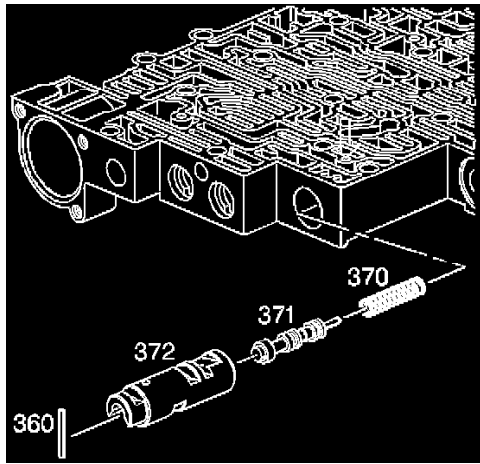
^ Chips/Sediment/Debris/Contamination found in the valve body, 1-2 accumulator valve (371) bore, may cause the 1-2 accumulator valve to stick or hang-up.

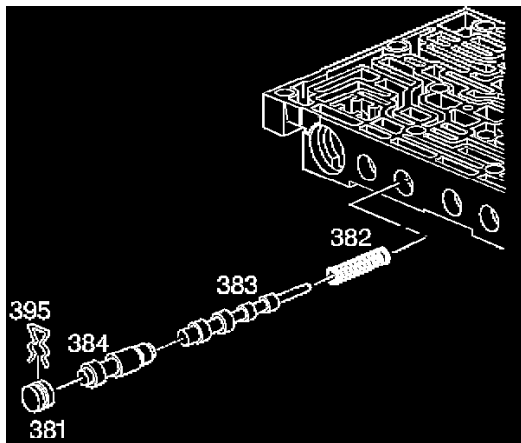
^ Chips/Sediment/Debris/Contamination found in the valve body, 4-3 sequence valve (383) bore, may cause the 4-3 sequence valve to stick or hang-up.

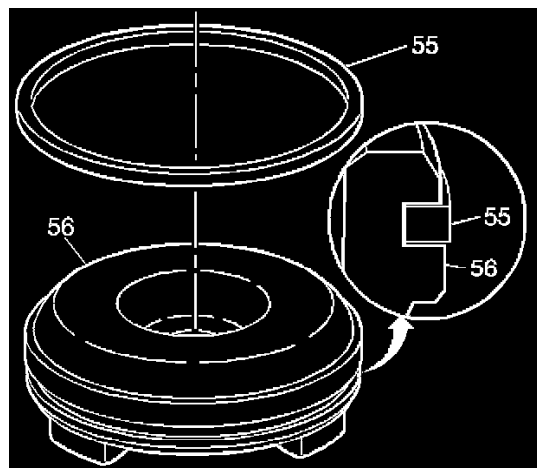
A cracked 1-2 accumulator piston (56) that is allowing fluid to leak by.

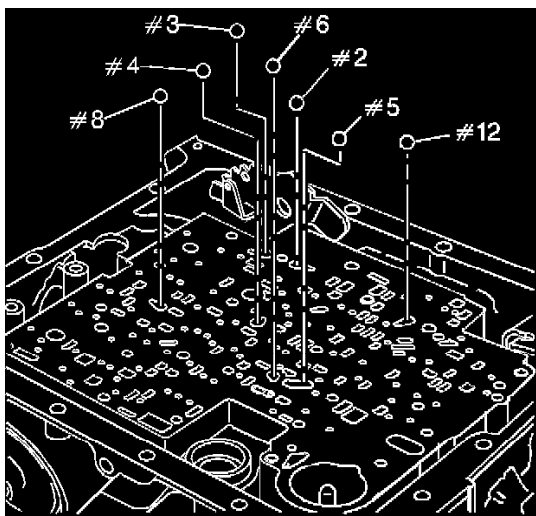
Mislocated/Missing valve body-to-spacer plate check balls (61).

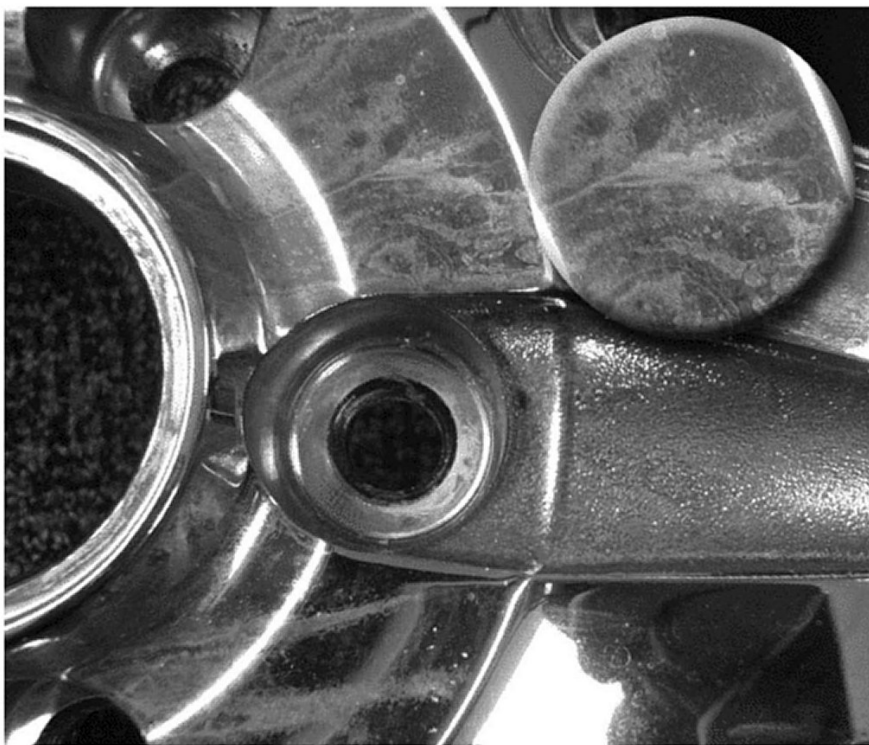
Chemical staining in most cases results from acid based cleaners (refer to Figure 1 for an example). These stains are frequently milky or greenish in appearance. They result from using cleaning solutions that contain hydrofluoric, oxalic and most other acids on chrome wheels (or any wheels). Soap and water is usually sufficient to clean chrome wheels, but if a cleaner must be used on chrome wheels, GM Chrome and Wire Wheel Cleaner, P/N 1052929 (in Canada, use P/N 10953202), or equivalent, is recommended. Do not use cleaning solutions that contain hydrofluoric, oxalic and most other acids on chrome wheels (or any wheels).

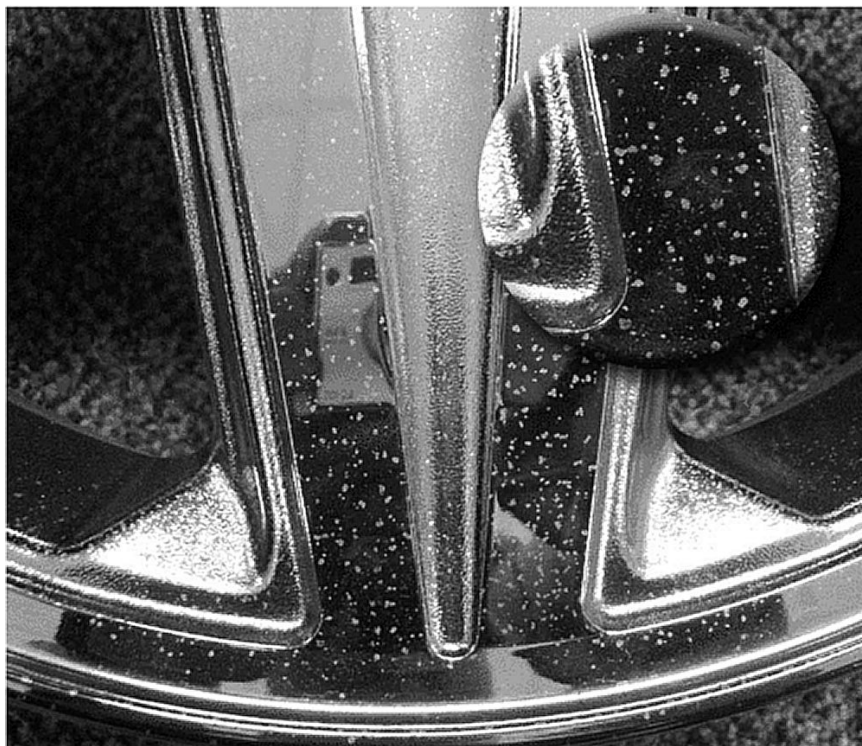
A second type of staining or finish disturbance may result from road chemicals, such as calcium chloride used for dust control of unpaved roads. The staining will look like small pitting (refer to Figure 2 shown). This staining will usually be on the leading edges of each wheel spoke, but may be uniformly distributed. If a vehicle must be operated under such conditions, the chrome wheels should be washed with mild soap and water and thoroughly rinsed as soon as conveniently possible.

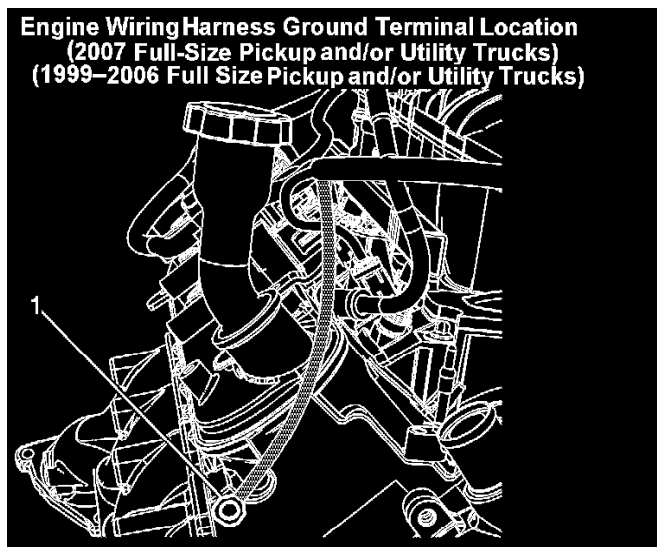
The wire terminal (G103) attaches either to the front or to the rear of the right side cylinder head, depending on the model year of the Full Size Pickup and/or Utility Trucks. If the ECM ground terminal has been found to be corroded, then follow the service procedure outlined in this bulletin to correct the corrosion issue.

Remove either the nut or bolt securing the main engine wiring harness ground terminal (G103) to the right cylinder head. Refer to the above illustration to determine where the ground is located on the vehicle (1).

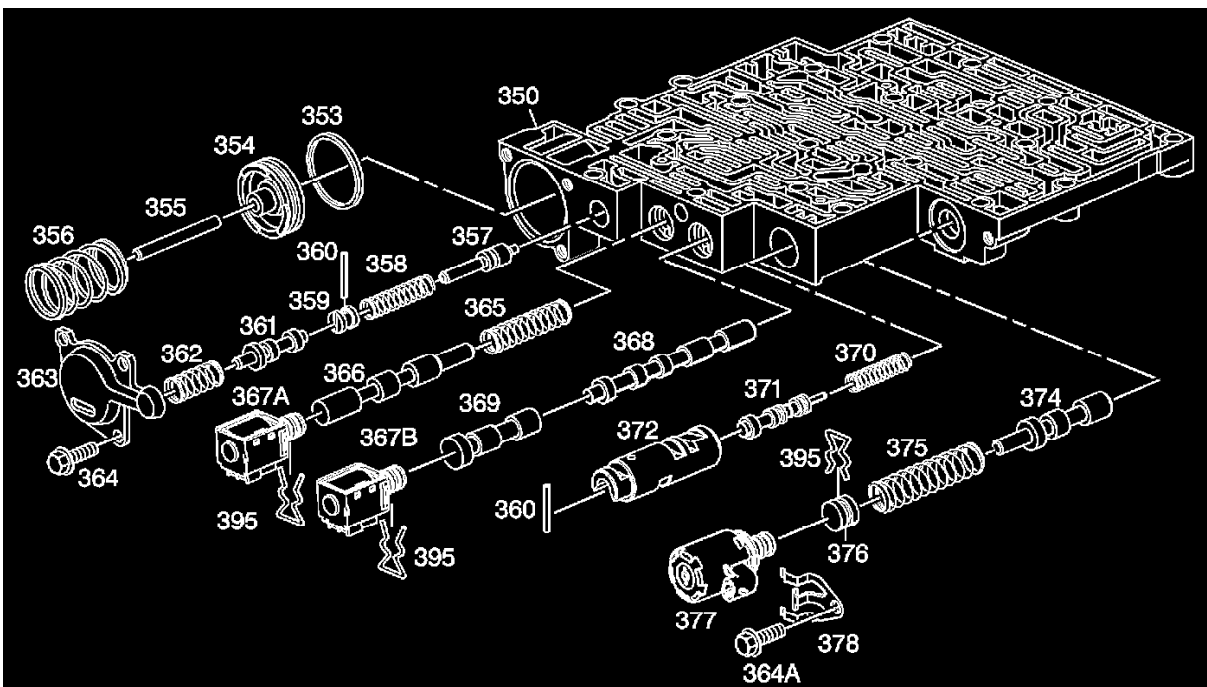
Chips or debris plugging the bleed orifice of the 2-3 shift solenoid (367). This will cause the transmission to stay in 2nd gear when 3rd gear is commanded and return to 1st gear when 4th gear is commanded.

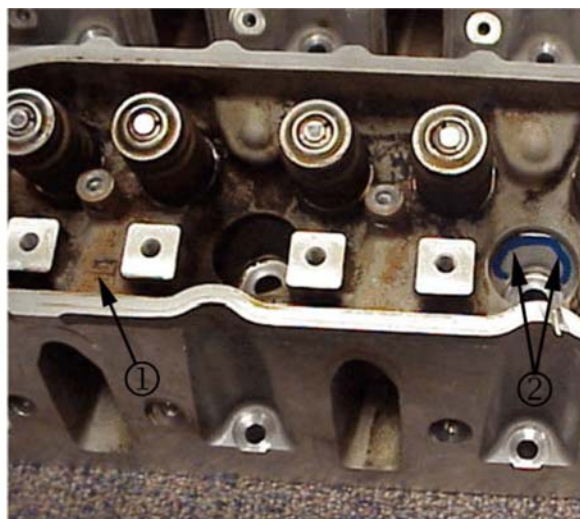
If the cylinder head(s) is a Castech casting (1), inspect the area around the five oil drain holes for witness marks indicating coolant seepage over time (2).

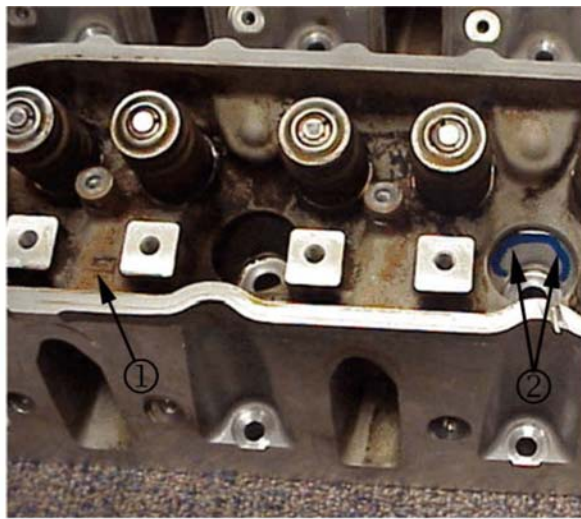
The crack location can be found in any of the five cylinder head(s) oil drains. This can be seen as a clean or shiny area, on an otherwise stained surface (1). Pressurizing the cooling system at this time may reveal coolant, air, or a combination, weeping in the described area. If inspection reveals evidence of coolant witness marks (1), replace the entire cylinder head(s) assembly.

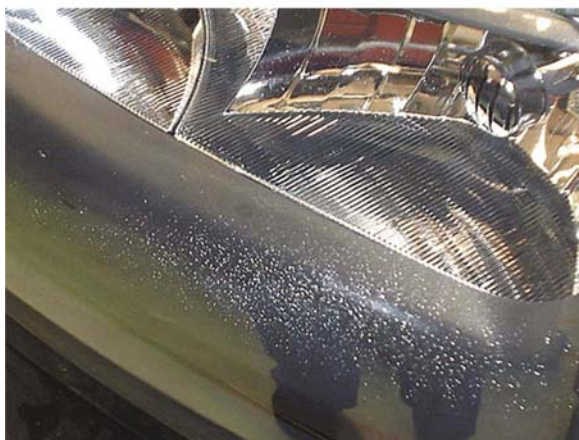
A Fine Mist or White Fog on the Inside Surface of the Lamp Lens Occuring After a Period of High Humidity

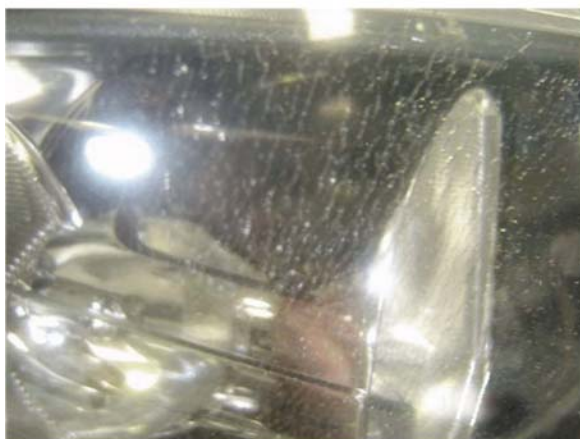
A condition that covers more than half the surface of the lamp lens. An accumulation of water in the bottom of the lamp assembly.

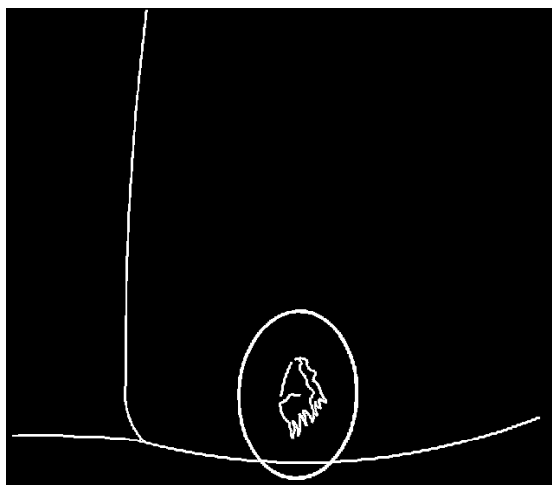
Customer induced cuts (knife cuts, cut by customer tools etc.)
