Vehicle: All Technical Service Bulletins

Technical Service Bulletin # 06-00-89-054

Subject:
Warranty Claims Submission - Importance of GM Part Numbers and Date Coded Parts

Models:
2007 and Prior GM Passenger Cars and Light Duty Trucks
2003-2007 HUMMER H2, H3
2005-2007 Saab 9-7X

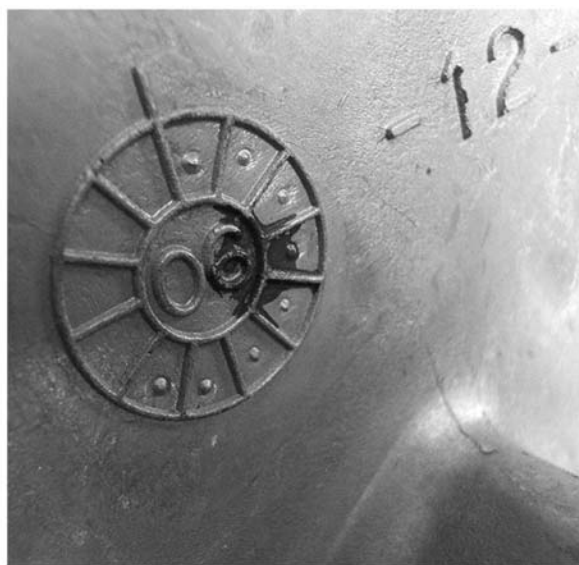
Date Code Example

The sample picture is from a 2.4L 4 cylinder front engine cover. On this part, the date code appears as a "clock" wheel.

On the first day for each month of production, the casting dye is pulled. Using a center punch, an operator manually punches another point on the date code wheel. To decode, you simply count the number of center punches, or impression, in the dial of the clock and you have the month.

The example picture has eight impressions, or center punch marks, on the wheel. The year is cast into the center of the dial or clock face. Therefore, the example is identified as being from August 2006. This date along with the part number, and many different identifiers cast into the parts, are used to track variations with multiple dies or production locations. When these marks are on the exterior surfaces when installed, they give GM dealers a powerful advantage when used for inspection purposes.

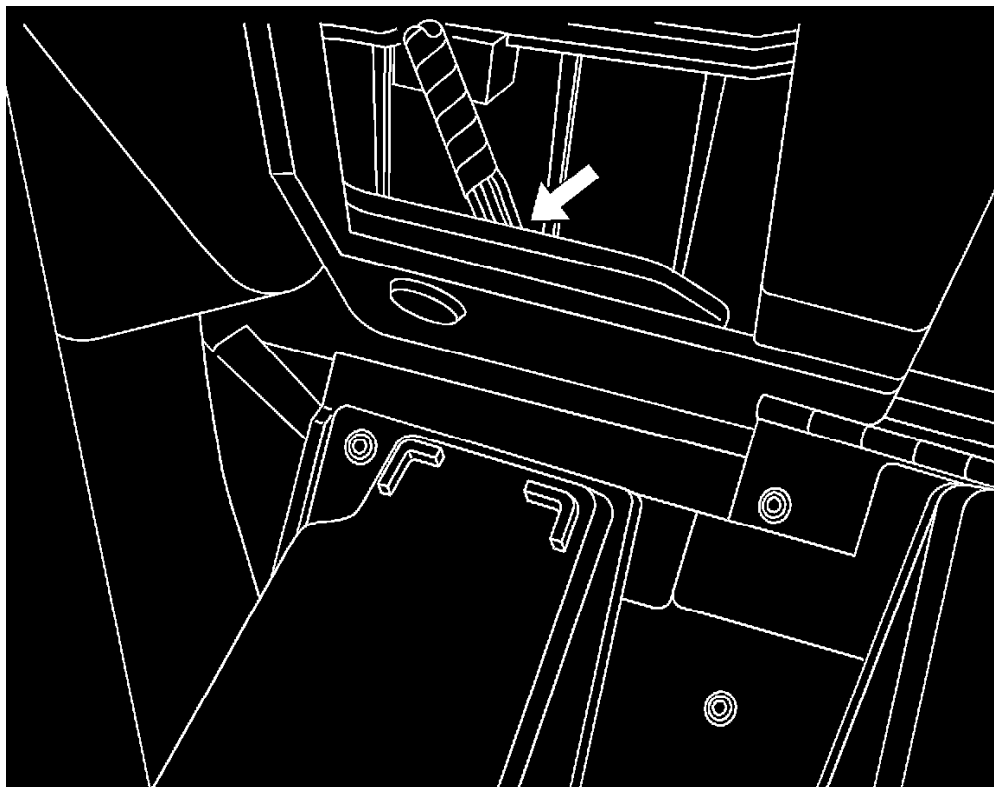
The HVAC actuator harness may contact a sharp edge on the instrument panel support brace, causing a rub through condition and a ground out of the actuator control and/or feedback circuits.

Locate the HVAC actuator harness contact point shown by the arrow in the above illustration. The illustration is of the instrument panel with the instrument panel compartment door opened and folded downward. The actuator harness is located in the left side of the opening in the instrument panel.

Technicians are to inspect the HVAC actuator harness for contact with the instrument panel support brace. Repair any damage to the actuator harness wiring and install protective plastic conduit over the harness. Install friction tape over the sharp edge of the instrument panel brace. Clear the diagnostic

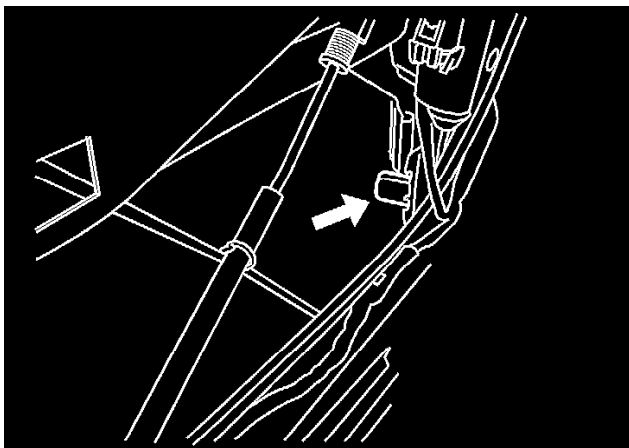
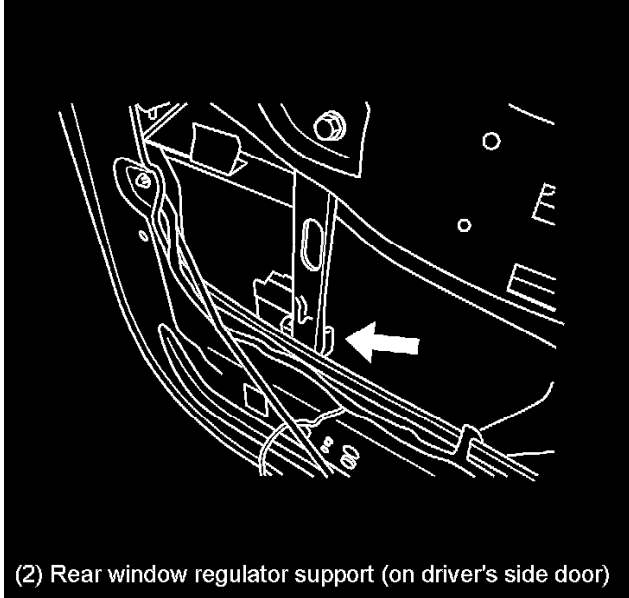
(1) Front window regulator support (on driver's side door)

9. Inspect the window regulator supports (both front and rear supports).
 - ^ If the rubber anti-noise sleeves are present and NOT damaged or worn, continue with diagnosis of the customer concern. Squeaks may also occur at the cable/pulley assembly, rail, and/or motor and gearbox housing.
 - ^ If the rubber anti-noise sleeves are damaged or missing, replace the sleeves with new polypropylene sleeves, P/N 19120848.
10. Reconnect the door electrical harness. Use the window switch to raise the regulator so that glass support is fully supporting the window glass.
11. Tighten the retaining bolts that hold the window glass to the window regulator assembly.

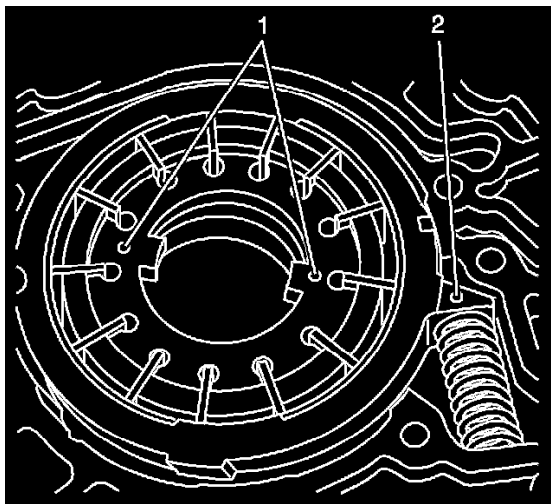
The second design oil pump rotor (212) and slide (203) are identified with dimples (circular depression) as shown above.

The rotor (212) has two dimples adjacent to the rotor drive tangs (1).

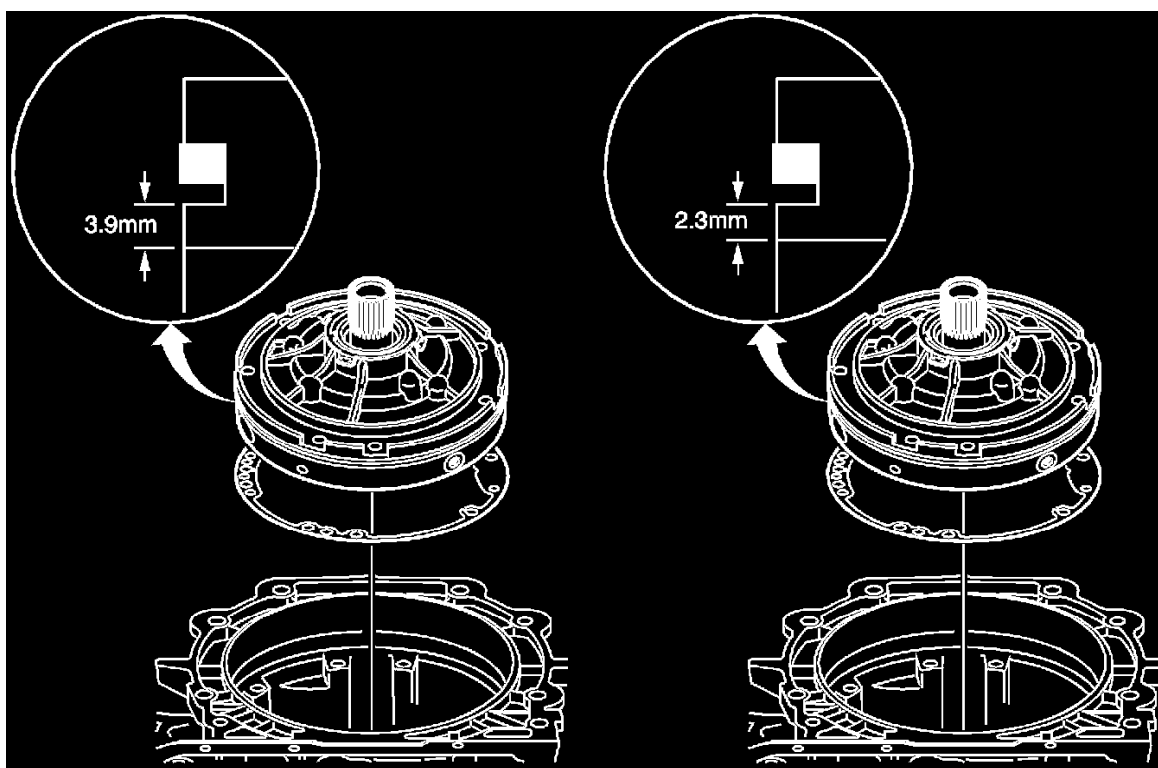
The first phase, beginning in September 2002, relocated the machining of the oil pump 0-ring seal groove in the pump body. The 0-ring seal groove moved 1.6 mm (0.62 in) inward on the pump body in order to place the sealing surface deeper into the case bore. The relocated pump body groove can be identified by measuring the groove location. Pump bodies that measure 2.3 mm (0.09 in) from the machined surface to the groove opening have the relocated 0-ring seal groove. Pump bodies that measure 3.9 mm (0.15 in) are prior to September 2002 design.

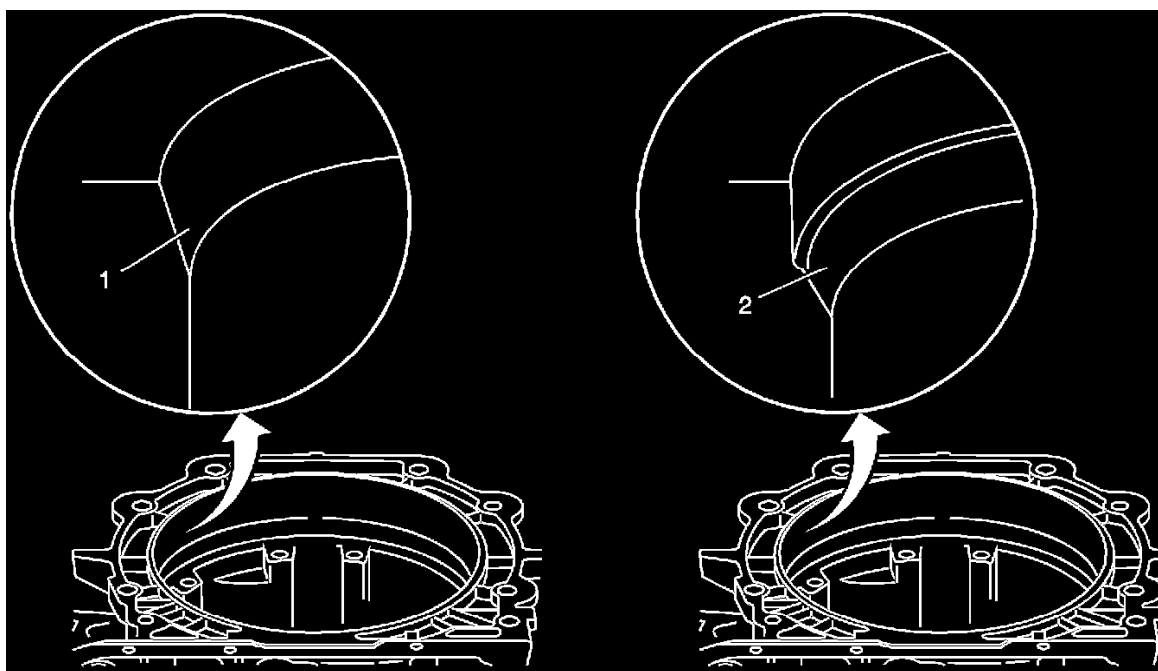
The first phase also machined a case chamfer leading into the pump bore (2). The chamfer is designed to help eliminate possible 0-ring seal damage during pump installation.

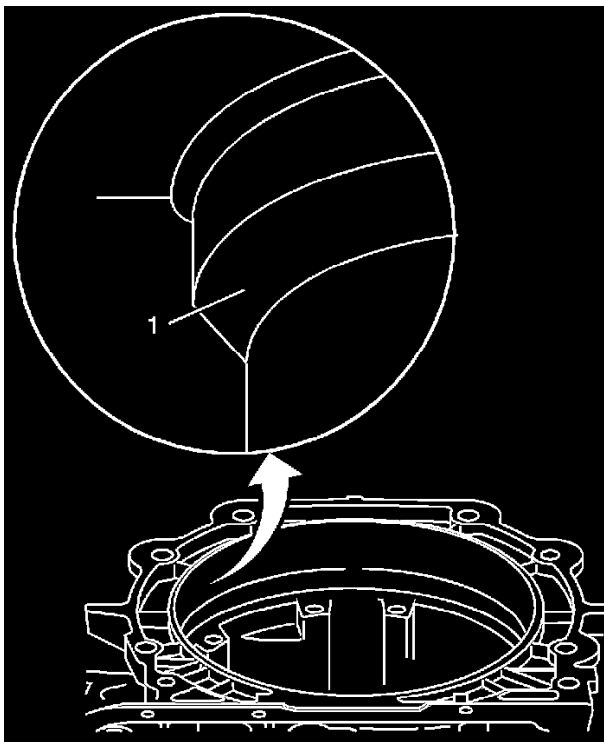
Phase two modified the case casting and the chamfer into the pump bore. The casting change left additional material in the surrounding pump bore to allow deeper bore machining in order to create the necessary sealing surface for a new pump seal design. The leading surface into the pump bore was also machined with a modified chamfer (1).

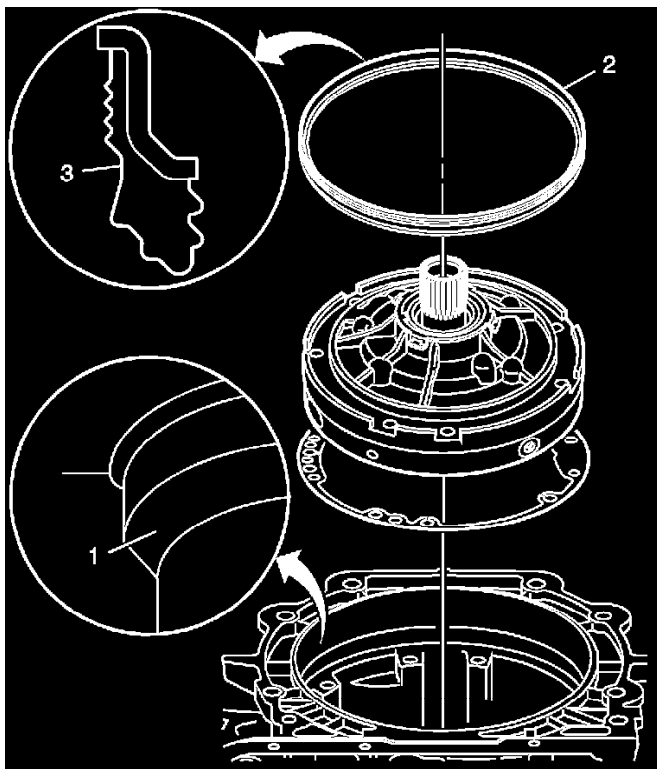
Phase three will eliminate the oil pump body O-ring seal groove and the O-ring seal. Beginning March 2004, a new stamped carrier molded rubber seal (2) will be used to seal the pump assembly to the transmission case.

The pump sealing surface is now the outer diameter of the pump and the inner diameter (1) of the transmission case bore. Unlike the current O-ring seal, which is installed on the oil pump body, the new seal is installed after the pump assembly is properly positioned and torqued in place. Seating the seal is accomplished when the torque converter housing is installed, which presses the seal (3) into position between the pump and the case bore (1).

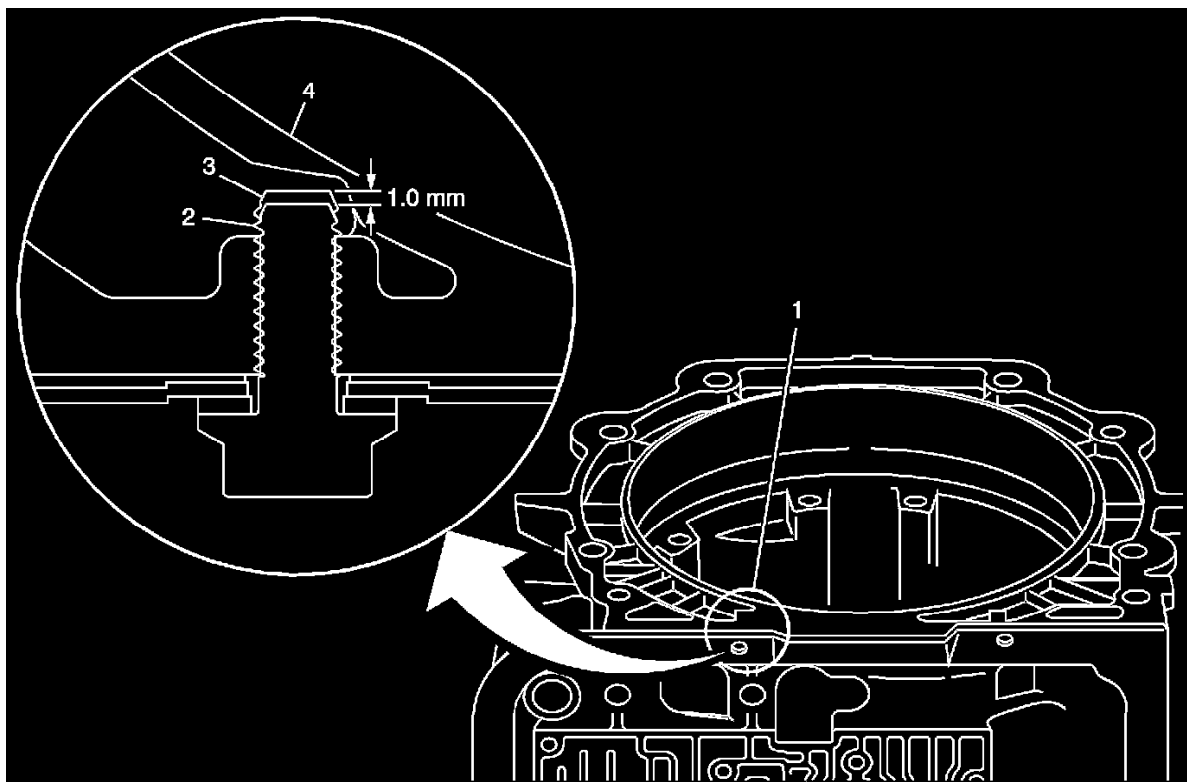
As a result of the modified casting and the deeper pump bore machining, the area between the oil pan mounting surface and the pump bore has decreased. Because of the reduced material in this area (1) it is necessary to use the shorter oil pan attaching bolts (2). Early pan bolts (3), before November 2002, should not be used with the modified case design, since they are 1.0 mm (0.39 in) longer and could deform the chamfer surface (4).

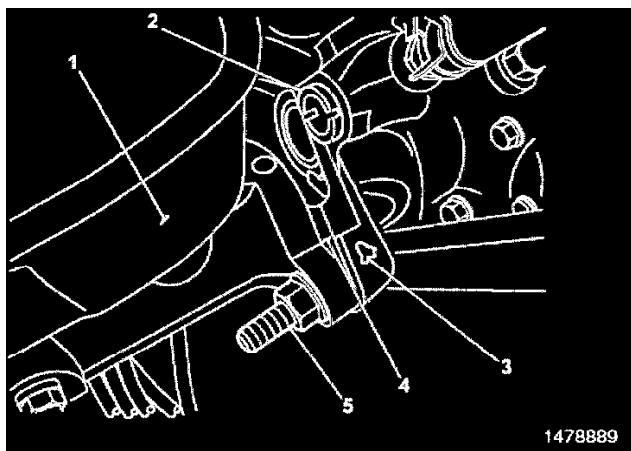
3. Inspect the hydraulic brake booster at the location shown (4) for a stamped number. The location (4) is the same surface that the master cylinder mounts on, just above the outboard mounting bolt and nut (5). Also inspect for a paint mark (3) near the master cylinder outboard mounting bolt (5). If a stamped number is found it will be a 1, 2, 3, or 4. If a paint mark is found, it will be yellow, pink, or white.

^ If a yellow, pink, or white paint mark IS visible, no further inspection or repairs are required. Disregard any stamped number found when a yellow, pink, or white paint mark is visible.

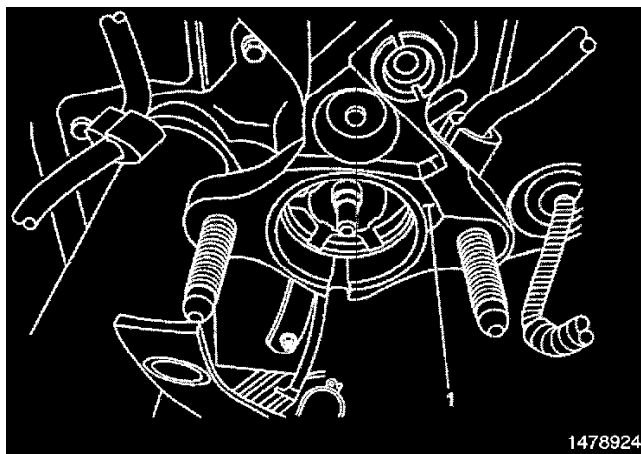
8. Inspect the machined surface that was covered by the master cylinder on the front of the hydraulic brake booster at the location (1) shown for a stamped number. The stamped number will be a number 1, 2, 3, or 4.
 - ^ If a stamped number 1 is visible, then the relief valve must be replaced. Proceed to the next step.
 - ^ If a stamped number 2, 3, or 4 is visible, then no further action is required. Proceed to Step 14 and reinstall the master cylinder.
 - ^ If no stamped number is visible, then no further action is required. Proceed to Step 14 and reinstall the master cylinder.
9. Cover the master cylinder with a clean shop towel in order to protect it from fluids or cleaners. Also, place a shop towel under the hydraulic brake booster to absorb any fluid that may leak out of the unit when the relief valve is removed in the next step.

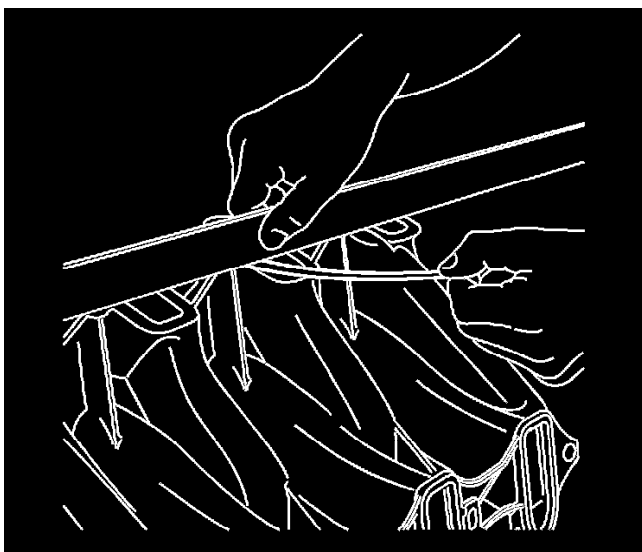
Inspect Intake Manifold to Cylinder head Deck for Warpage

The intake plenum should also be checked for excessive warpage that may cause an uneven clamping pressure of the seal. If the plenum is found to be warped it will need to be replaced. Service Information states, "An intake manifold with warpage in excess of 3 mm (0.118 in) over a 200 mm (7.87 in) area should be replaced." Intake warpage is measured at the gasket sealing surfaces and should be measured within a 200 mm (7.87 in) area. This measurement is across only two of the intake runner port openings. Measurements taken across the entire distance of all four intake runner ports will lead to unnecessary manifold replacements.

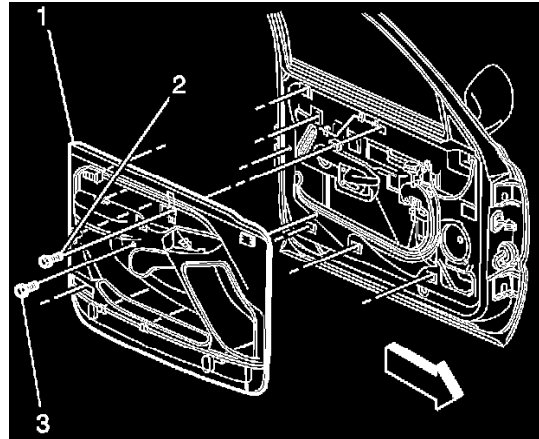
The purpose of this bulletin is to remind technicians to follow the front door trim panel removal procedure in SI. The front door trim panel will break if the screw at (2) in the illustration above is not removed. In order to prevent door trim panel breakage, follow the Trim Panel Replacement - Side Front Door procedure in SI.

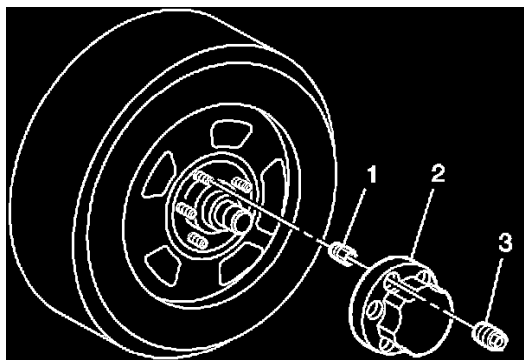
The nut cap system is designed to skip a thread if over-tightened. DO NOT replace the hubcap assembly if this happens.

Hold hubcap (2) firmly in place on wheel with the plastic wheel nut caps (3) aligned with the steel wheel nuts (1). Hand snug each nut cap (3) (using a hand held deep socket or torque stick) until fully seated against the hubcap (2). You should feel the nut cap (3) ratchet against the hubcap (2) a couple times as the nut cap (3) seats. After all nut caps (3) have been seated, check tightness of each nut cap (3) using the socket or torque stick and tighten any nut cap (3) that may have loosened. If a nut cap (3) jumps thread (a design feature to prevent damage) and becomes loose during tightening, continue to tighten and stop short of thread jump.

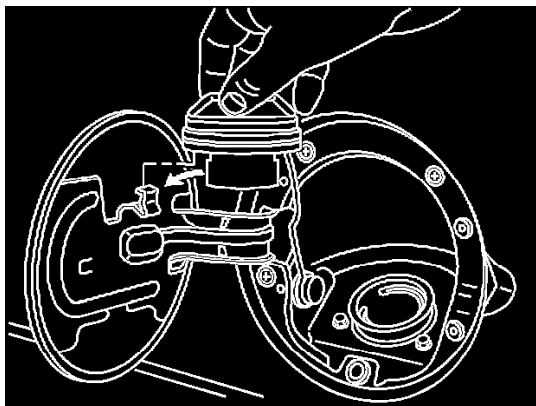
This bulletin is being issued to inform dealers that there are two different types of fuel caps used on all 2004 full-size pick-ups and utilities with gasoline engines. A threaded design is used with the E-85 5.3L (VIN Z - RPO L59) engine. A 1/4 turn design is used with all other gas engines. The 1/4 turn design has a shorter tether strap and will not allow the customer to drape the fuel cap over the hook on the filler door. However, as designed and per the vehicle's Owners Manual, the cap can be retained in the hook by the lip of the fuel cap.

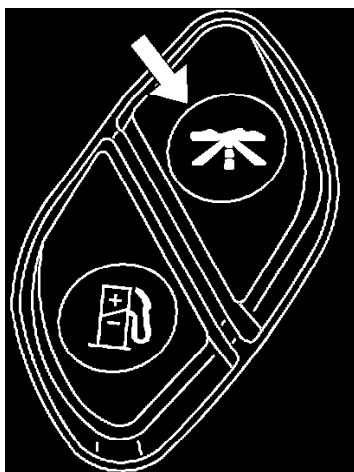
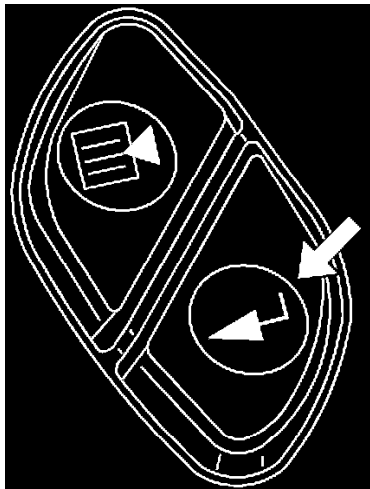
The purpose of this bulletin is to prevent the inadvertent replacement of the instrument cluster if a customer comes in to your dealership stating that the trip odometer is inoperative or does not accumulate.

For vehicles with steering wheel controls, the Personal Trip (or Business Trip) feature must be turned On in order for the trip odometer to accumulate.

When the display reads Personal Trip: On (or Business Trip: On), the trip odometer shall accumulate.

The Personal Trip and Business Trip features can be turned on or off by pressing the select button. Refer to Driver Information Center (DIC) in the Owner's Manual for additional information.

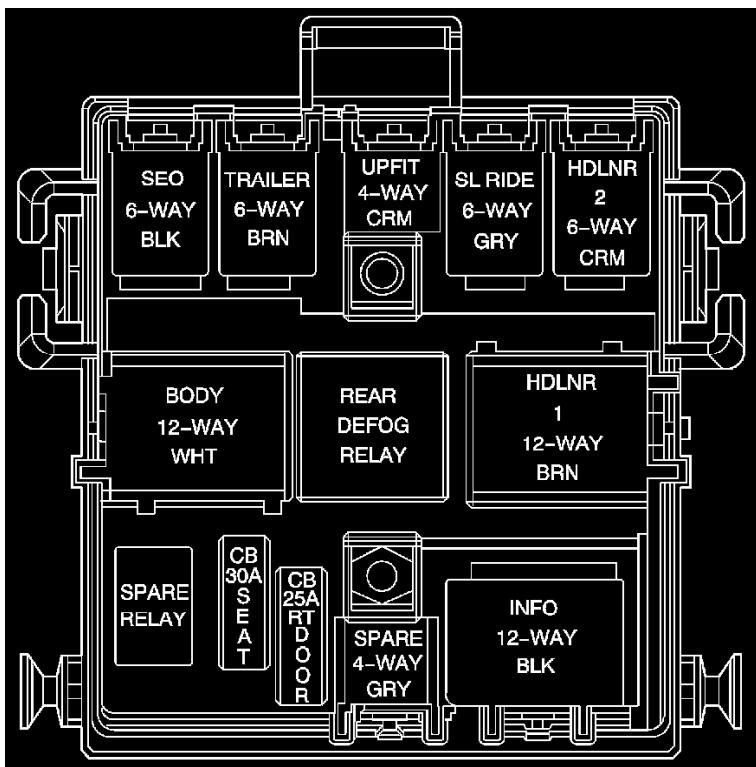
The cause of this condition may be due to wiring changes within the vehicle electrical system for the 2003 model year.

Inspect the brake controller wiring harness jumper that is plugged into the vehicle relay block-body. The relay block-body is located under the left side of the instrument panel near the left kick panel, behind a plastic cover.

The 1999 through early 2003 wiring harness jumper that plugs into the relay block will have a reddish/brown 6-way connector and a tag with the last four digits of the wiring harness part number. Second design 2003-05 may have a white plastic connector with part number 5418 as well.

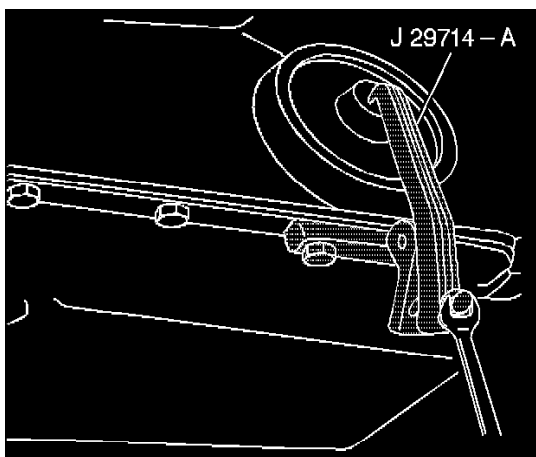
This condition may be caused by a servo cover retaining ring that did not retain the servo cover.

1. Raise and suitably support the vehicle.
2. Inspect the transmission case around the servo cover for signs of cracks or damage to the case.
 - ^ If the transmission case is cracked or damaged, replace the transmission case. Refer to the appropriate SI Document for Transmission Case Replacement.
 - ^ If the servo cover is leaking and the case is not damaged, continue with the next step.
3. Remove the front exhaust pipe assembly. Refer to the appropriate SI Document.
4. Remove the heat shield if equipped. Refer to the appropriate SI Document.
5. Clean the servo cover area with Brake Clean and shop air.

6. Install the J 29714-A.
7. Compress the servo cover with J 29714-A.

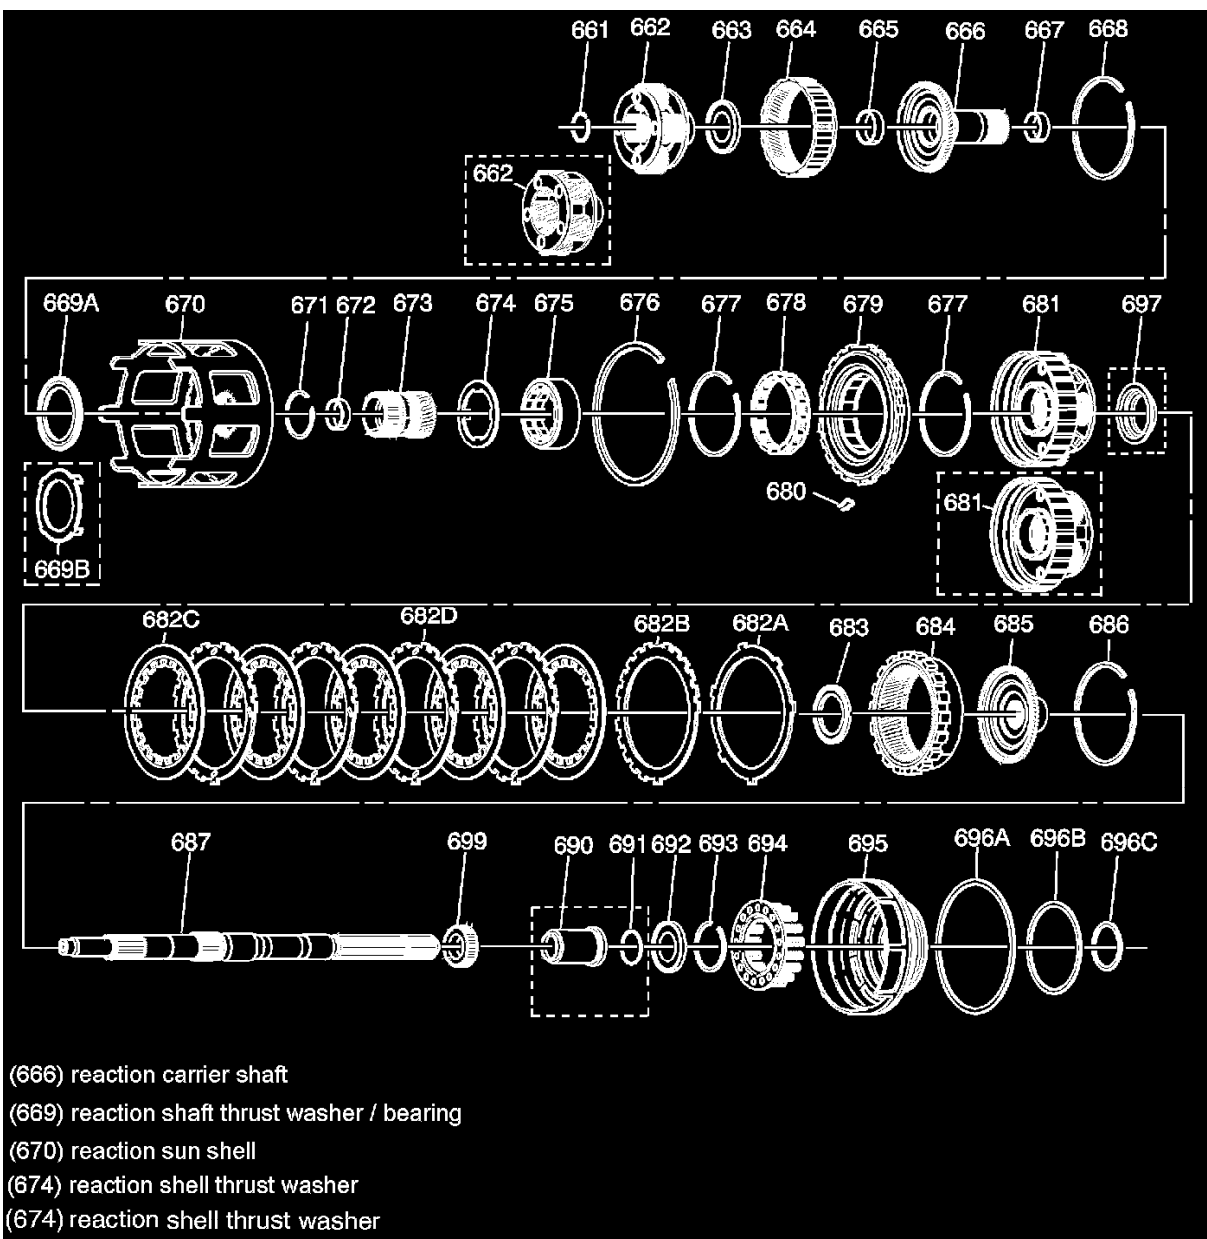
If metallic debris is found on the transmission magnet, the transmission must be completely disassembled and cleaned. Metallic debris is defined as broken parts and pieces of internal transmission components. This should not be confused with typical "normal" fine particles found on all transmission magnets. Failure to properly clean the transmission case and internal components may lead to additional repeat repairs.

1. Remove the transmission oil pan and inspect the magnet in the bottom of the pan for metal debris.
2. Remove the transmission from the vehicle. Refer to the appropriate SI document.

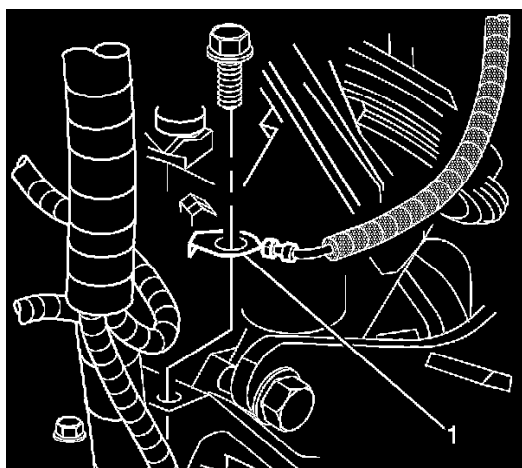
The wire terminal (G103) attaches either to the front or to the rear of the right side cylinder head, depending on the model year of the Full Size Pickup and/or Utility Trucks. If the ECM ground terminal has been found to be corroded, then follow the service procedure outlined in this bulletin to correct the corrosion issue.

Remove either the nut or bolt securing the main engine wiring harness ground terminal (G103) to the right cylinder head. Refer to the above illustration to determine where the ground is located on the vehicle (1).

Remove all rust from the ground terminal, the cylinder head and the retaining nut or bolt.

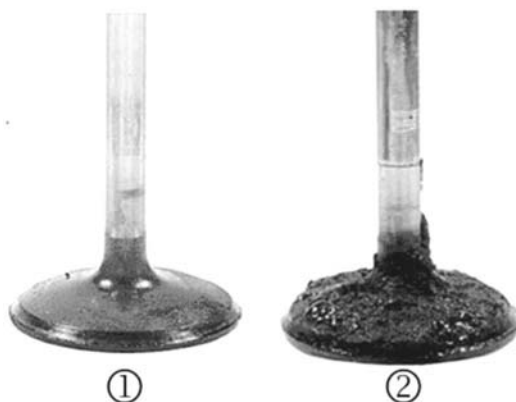
Intake valve: 10,000 miles with TOP TIER Detergent Gasoline

Intake valve: 10,000 miles with Legal Minimum additive Gasoline

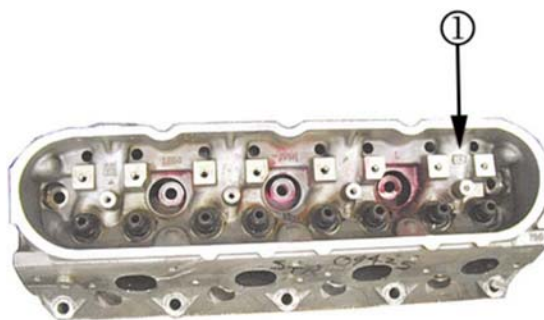
Some vehicles may experience a gradual coolant loss over time. A very low percentage of cylinder head(s) manufactured with an embossed Castech logo may develop a porosity crack in a very specific area.

Cylinder head(s) location of the Castech manufacturing casting logo (1).

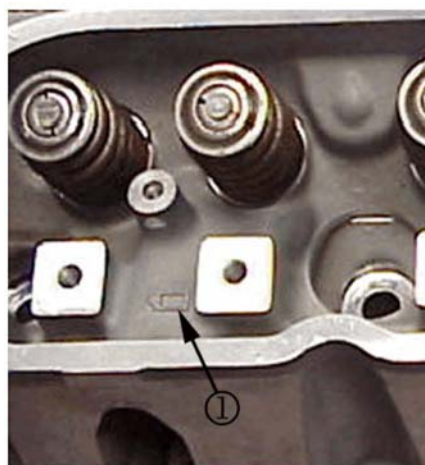
Close up view of the cylinder head(s) showing the Castech manufacturing casting logo (1).

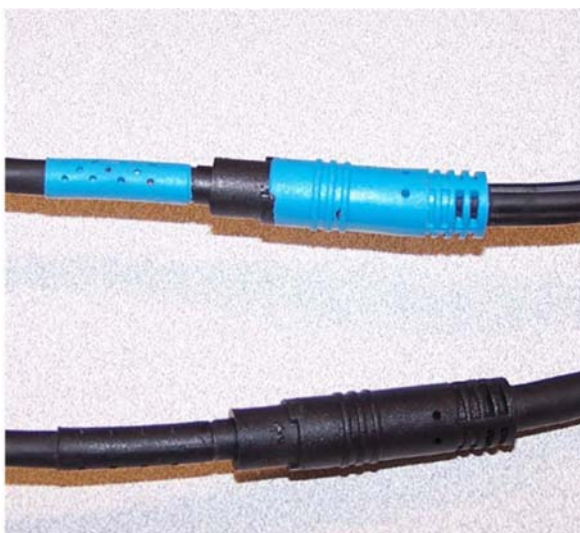
A number of headrest monitors have been replaced under warranty and in many cases, no trouble was found by the supplier when these units were analyzed. Therefore, technicians should be checking for loose connections and installing cable connector clamps to ensure a positive and robust connection.

The illustration above shows a pair of display monitor cable connectors without the cable clamps installed.

Technicians are to install a video cable connector clamp on each cable connector located under each front seat. A total of four cable connector clamps, P/N 19159659, are required for each vehicle.

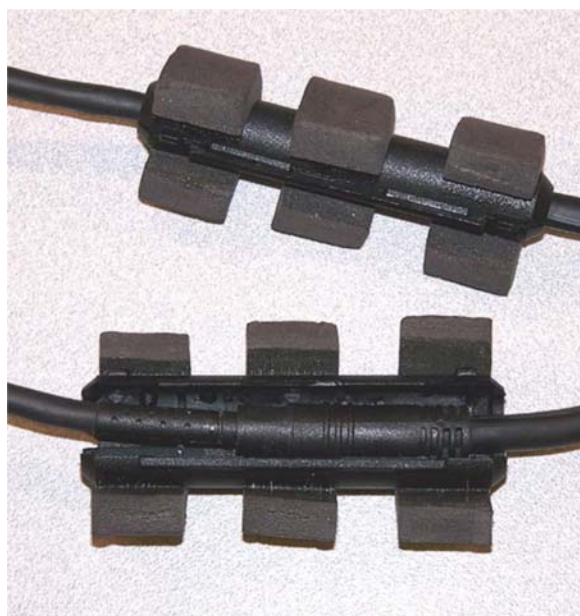
The illustration above shows the display monitor cable connectors with the cable connector clamps. The lower cable connector clamp is installed but not locked together. The upper cable connector clamp is closed and locked.

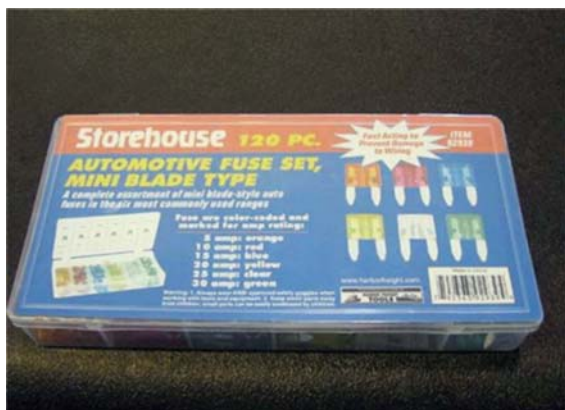
How to Identify These Fuses

Upon testing the 15 amp version, it was found that the fuse still would not "open" when shorted directly across the battery terminals.

Packed in a 120 piece set, the fuse has a translucent, hard plastic, blue body with the amperage stamped into the top. There are no white painted numbers on the fuse to indicate amperage. There are no identifying marks on the fuse to tell who is making it. The fuses are known to be distributed by Harbor Freight Tools but there may be other marketers, and packaging of this style of fuse. It would be prudent to replace these fuses if found in a customers vehicle. Likewise, if wiring overheating is found you should check the fuse panel for the presence of this style of fuse.

All GM dealers should use genuine GM fuses on the vehicles they service. You should also encourage the use of GM fuses to your customers to assure they are getting the required electrical system protection. GM has no knowledge of any concerns with other aftermarket fuses. If additional information becomes available, this bulletin will be updated.

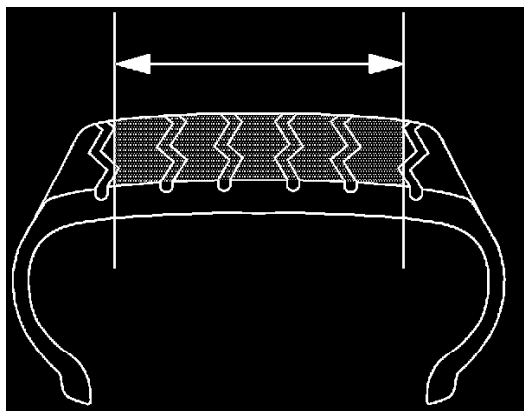
Repairable area on a radial tire.

NEVER repair tires worn to the tread indicators 1.59 mm (2/32") remaining depth).

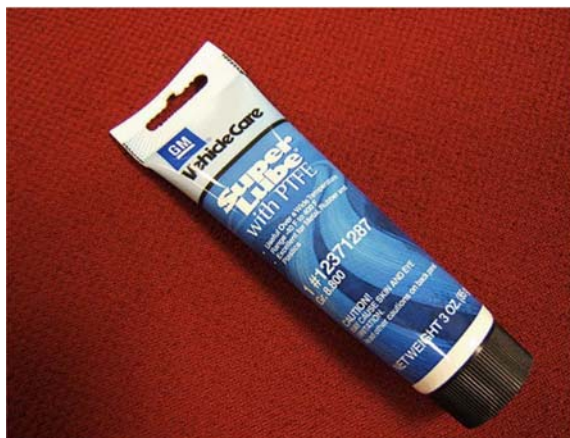
Frequently, dealer installed accessories, whether aftermarket or GM-approved, may require drilling holes into the body panels or supports to complete installation. Whenever you drill into a metal surface, the corrosion resistance of that panel is compromised. Testing was conducted to determine the best method used to protect the fastener-to-panel mounting holes from future corrosion. Several commercially available sealers and coatings were evaluated.

In all cases, GM Vehicle Care Super Lube(R) with PTFE performed the best at preventing corrosion in fastener to panel interface holes and is now the official GM recommended product as shown in the above illustration. It is recommended to apply the GM Vehicle Care Super Lube(R) with PTFE, to any hole and fastener before installing the fastener into the drilled attaching hole or inside the metal panel.

GM Vehicle Care Super Lube(R) with PTFE is the only product recommended and required by GM for the corrosion protection of metal panels where fasteners will be added to metal panels.

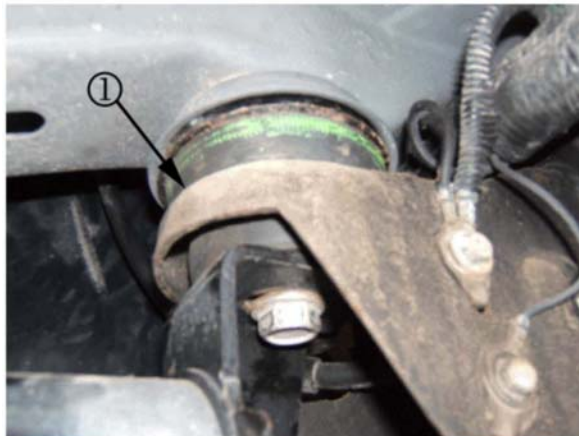
While the body mount is removed, check the underbody area that interfaces with the top of the body mount for excess build-up of E-Coat Primer or other foreign material. If the surface is not smooth use a 90 degree die grinder, or equivalent to remove the excessive build-up. Apply an anti-corrosion protection, P/N 12378398 (in Canada, 10952414), to the bare surface as necessary to prevent rusting.

Install the new insulator to the bottom of the top portion of the # 1 body mount. The picture shows the insulators (1) location after the body mount is reassembled.

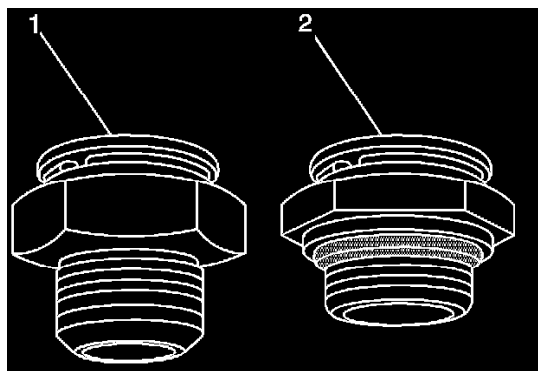
Aluminum cooler line fittings - These new fittings (2) cannot be used on earlier cases because the threaded hole is not the same size. Old style fittings (1) will continue to be available through SPO parts.

Service cases will be the new case and fittings. The old cases with the old thread design will not be maintained for service. The connection on the hose side will accept both the short snout and the newer longer snout cooler hose assemblies.

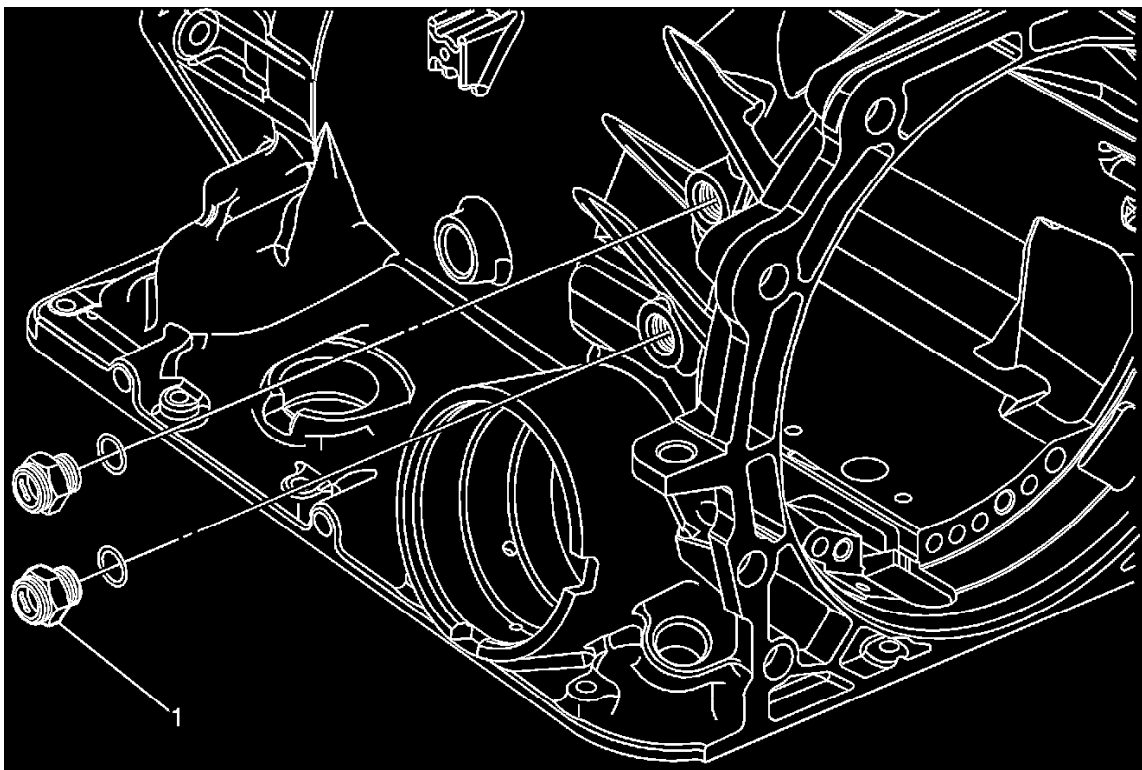
The fittings (1) have a new torque specification of 20 N.m (14 lb ft). They also have one inner and one outer "O" ring that are not serviced separately. The new thread size 9/16-1a UNF-2A (1) was implemented on 11-29-07 or Julian date 333.

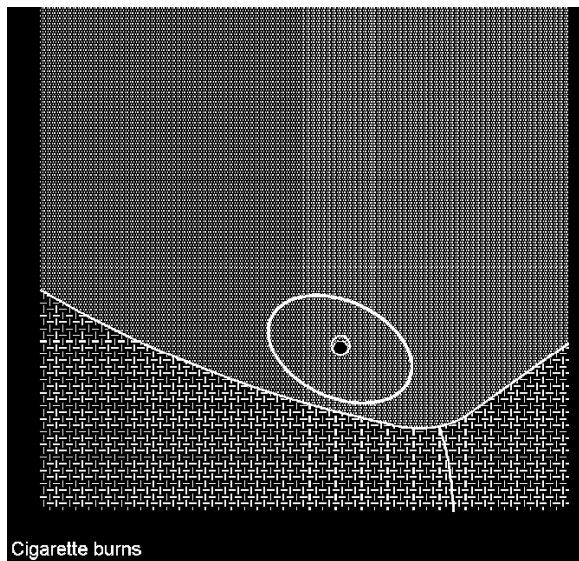
If a customer comes in to your dealership due to certain conditions of the seat covers (splits, wrinkles, loose stitching, etc.), you must examine the seat cover in order to determine the validity of the customer claim. Some components from the above listed vehicles have been returned to the Warranty Parts Center (WPC) and analysis of these parts showed "customer induced damage" or No Trouble Found (NTF).

Inform the customer that the above issues were not present when the vehicle was purchased and cannot be replaced under warranty. The covers, however, may be repaired or replaced at the customer's expense.
